## ANALYSIS OF GEAR DAMAGE CAUSES USING MICROHARDNESS AND METALLOGRAPHIC TESTING

*Different types of damage can occur on the coupled teeth of gears. This paper presents the procedure for testing and analysis of the causes of hip gear teeth from a crane gearbox. The goal of this research was aimed to examine and to analyze the faults that occurred in the damaged teeth of gears made of steel E335 by BAS EN 10027-1 (Č.0645) and to determine what led to the formation of these defects. Experimental part of this research was performed by sampling from three selected gear tooth samples. Two teeth were damaged and there was one undamaged gear tooth. Metallographic and mechanical tests were carried out in order to resolve the respective issues, which occurred at the gear teeth sides. The results of metallographic and mechanical tests indicate that the damaged gear teeth were heavily loaded, and they were improperly welded afterwards, which led to the progressive formation of cracks around the side of the tooth.*

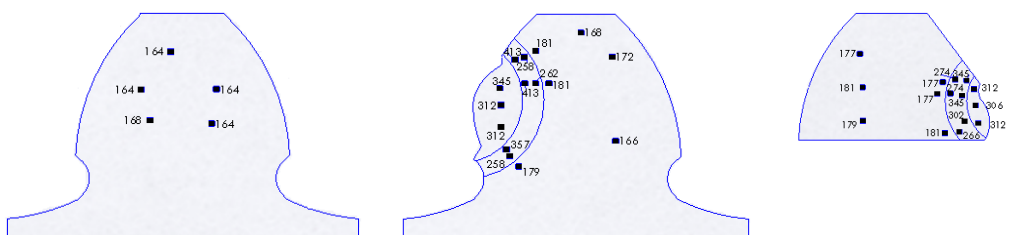
Figure 2. Locations of micro hardness tests

Figure 2 shows locations of micro hardness tests. All gear teeth were tested on locations referred to as a basic material, and damaged teeth (b, c) were tested inside a weld and inside the heat-affected zone. Measurement results, shown in Table 1, show that hardness of undamaged gear tooth is uniform and has value of 164 HV10 across whole cross-section.

Sample (b) was tested in 15 different locations. Basic material has hardness between 166 and 181 (average 17.5 HV10). Lowest hardness 166 HV10 is registered in the middle of the sample, and hardness in heat-affected zone increases. The highest value in heat-affected zone is 357 HV10, while average hardness is 326.8 HV10. Within the weld, hardness is between 312 and 345 HV10, and average is 323 HV10.

Sample (c) was measured at 15 locations. Basic material hardness is between 177 and 266 (average 192.8 HV10). Lowest value 177 HV10 is measured in the middle, increasing towards heat-affected zone. Lowest value in heat-affected zone is 274 HV10, and the highest value is 345 HV10, both in gear tooth side. Welded part had uniform hardness with average value 310 HV10.

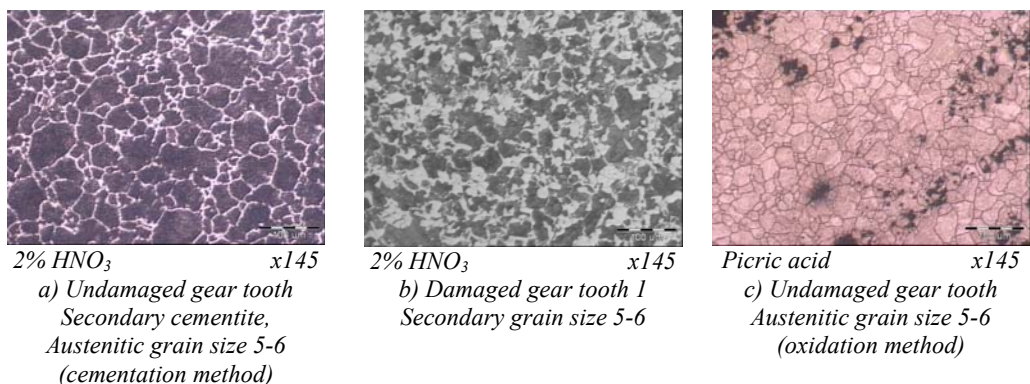
Figure 4. Metallographic test results

Fig. 4 shows results of metallographic tests. Undamaged gear was tested by cementation method (Fig. 4.a). The carbon diffused by grain edges and formed mesh of secondary cementite (Fe<sub>3</sub>C). Secondary grain size was tested by method ASTM E112 (Fig.4.b). Undamaged tooth was tested by oxidation

method (Fig.4.c). The microstructure is inhomogeneous and the surface is oxidised. The grain size is 5-6. These tests showed lack of hardened surface and damaged gear teeth had heat-affected zones. Microstructure in all samples was ferrite-pearlite, with grain size 5-6, which provides good mechanical characteristics.

Metallographic examination revealed the absence of a hardened surface, and the two damaged gear teeth expressed existence of the heat effect zone and weld metal in the area on both tooth sides. These two damaged gear teeth also expressed dent in the side of the tooth that was filled with oxide. The microstructure of all three tested samples showed a uniform ferrite-pearlite structure. The secondary grain size on all three samples is between 5 and 6. To assess the size of austenite grains, detection of austenitic grain was performed using Mc Quaid – Ehn method of carburisation followed by etching with 2% $\text{HNO}_3$  solution and the oxidation method was performed with picric acid etching. Testing of austenitic grains of all three samples of gear teeth revealed medium grain size, between 5 and 6, which guarantees favourable mechanical properties.

The working life of the this gear would be significantly extended if the gear teeth were surface-hardened or cemented.
